'Premium' Residential Property Inspection On

Date of inspection: 6th June 14
Weather conditions: Dry
Previous Weather conditions: Variable
Compass bearing from official front door: North East facing

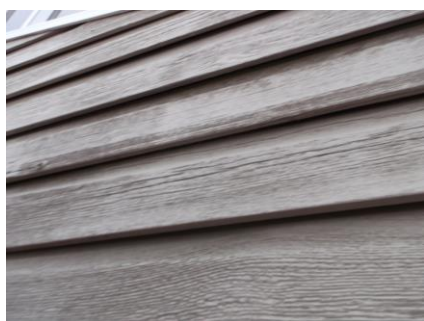
The rusticated weatherboard cladding has been affected by exposure and lack of product treatment prior to receiving paint application.

Cupping boards and distortion as a result of past deferred maintenance is noted.

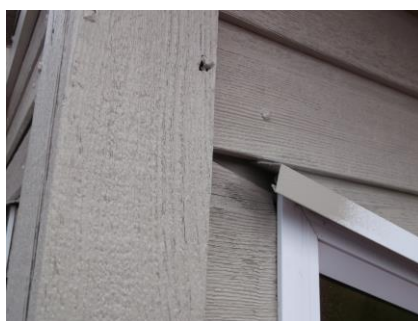
Voids to some head flashings and exposed rustic plug indents will require sealing using paint suitable exterior construction grade MS sealant products.

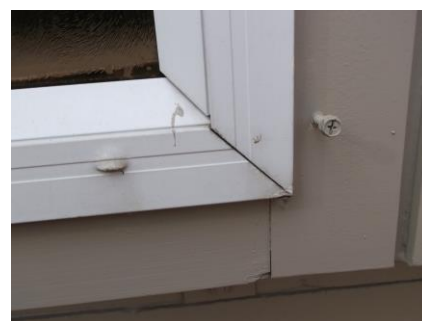
Failures to the stairwell sill mitres are suspected to be the cause for moisture ingress detected in the interior sill lining. Full depth sill flashings are likely required.

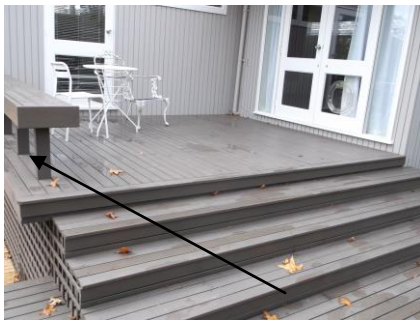
Handrail is required to the rumpus decking.

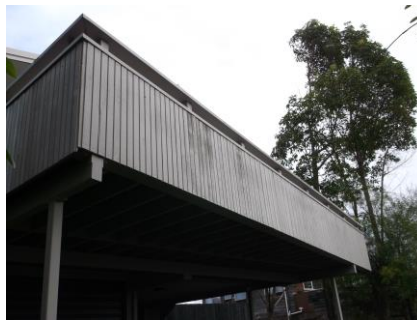
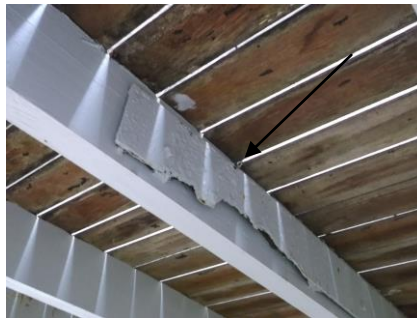
Right – Corrosion to walkway joist reinforcement. It is unclear how the cantilever has been formed.
 Far right – Additional bearer support is a recommendation.
 Joist hangers are strongly recommended to further stabilise the handrail.

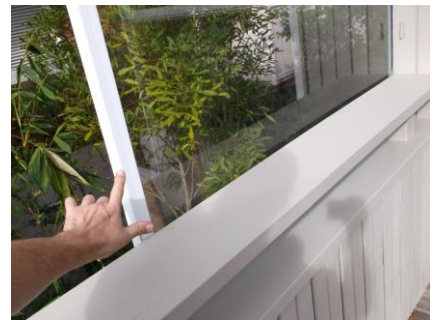
Further secure glazed screen.

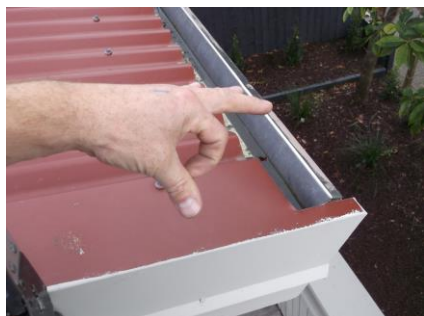
Pooling water collections are noted to the N corner. Overflowing is expected.

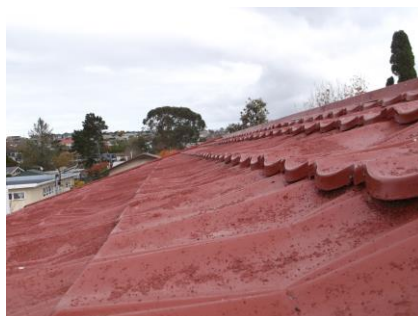
Right – Upgrading and completing remedial work to the plumbing soil and vent penetrations through the roofing is strongly recommended / required.

- Employing the services of a trade registered professional to seal the window door rusticated indents.
- Employing the services of a trade registered professional to further seal the soil vent stack penetrations through the roofing.

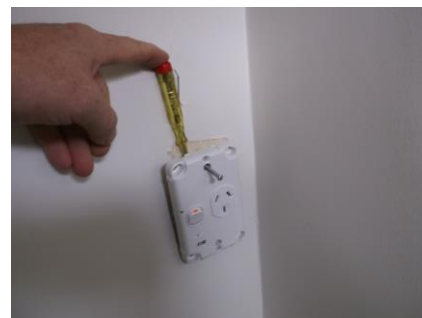
No current detected to this power point in the N/W corner bedroom.

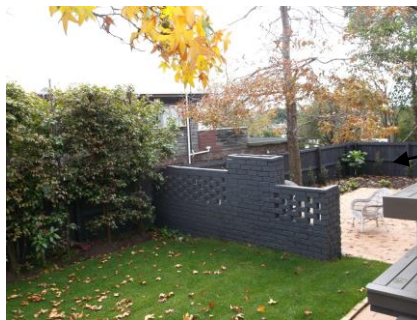
Attention to the fencing where back filled against as retaining is noted local to the courtyard area.

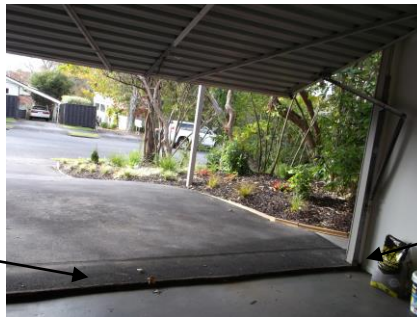
Driveway 'build-up' is above the garage flooring height.

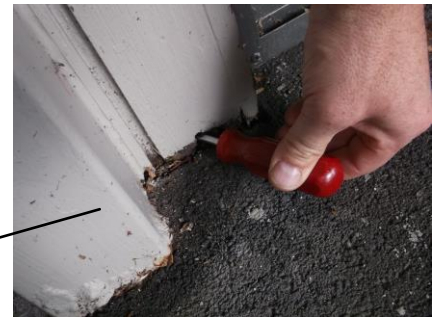
Rot associated with ground clearance compromise and capillary moisture penetration is noted. Remedial work and remodelling is required.

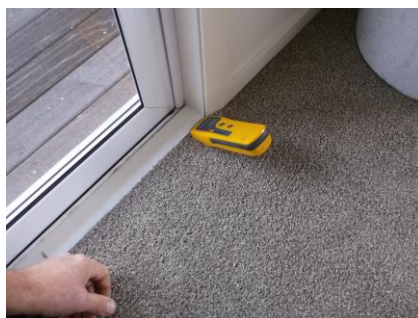
Elevated moisture concentrations in the lounge N/W elevation exterior door sill R/H corner suggests collected water 'wicking' past suspected unsealed mitres is the likely cause.

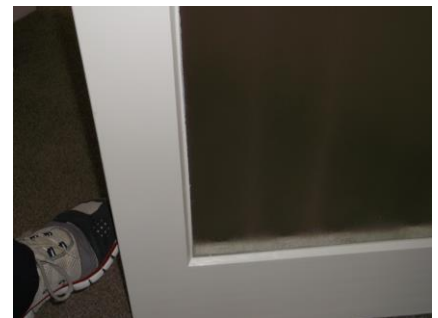
Right – Upgrading internal door glazing to suit safety type is recommended.

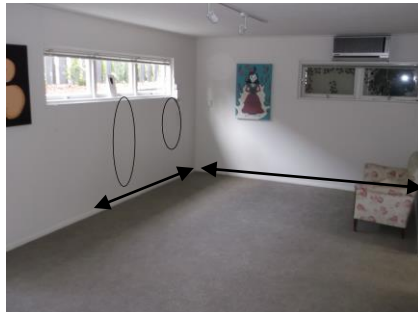
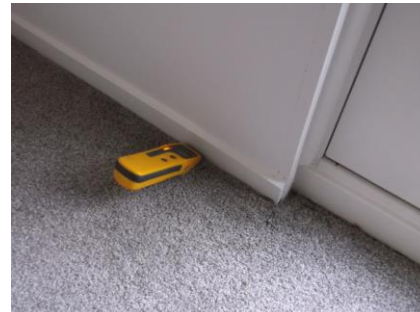
Moisture concentrations above the accepted average are present in the wall linings and skirting trim to areas associated with subterranean elevations. Given location and pattern, damp proofing failures are the suspected cause.

Right – Moisture concentration patterns are signatures of suspected DPM failures and subsequent moisture ingress. Extensive remedial work will be required to reapply appropriate exterior / interior products to create a permanent water proofing surface.

Engaging the services of a water proofing specialist to further assess prior to completing all remedial work requirements to a satisfactory conclusion.

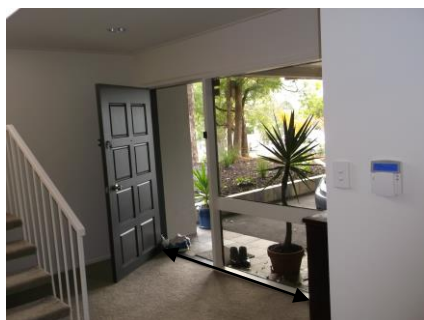
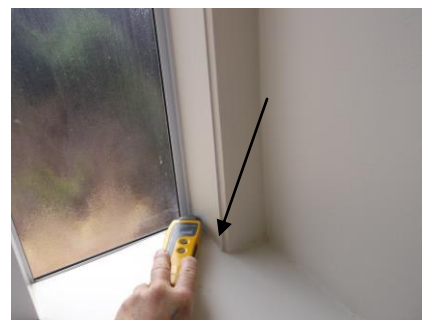
The entry, stairs and hallway are in generally good / average condition. Moisture concentrations above the accepted average are present in the front door and associated window sill. External ground clearance compromises are the cause. Attention will be required. Moisture concentrations above the accepted average are present in the stairwell window sill corners. Failing mitres are the likely cause. Further assessment and remedial work is required. Full depth mechanical sill flashings are likely required.

Left – Moisture concentrations in the window / door are as a result of moisture capillary action from the compromised ground clearance. Right – Moisture concentrations here in the stairwell window sill is likely as a result of collected water in the sill profile 'wicking' past unsealed mitred joinery. Condensation may be a contributory factor

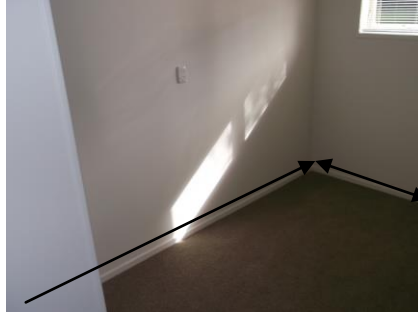
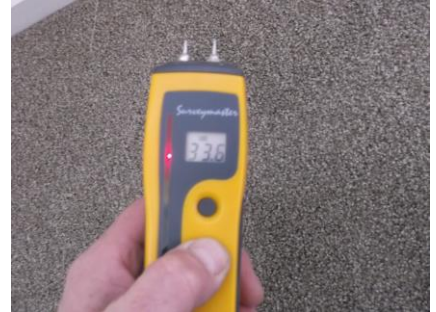
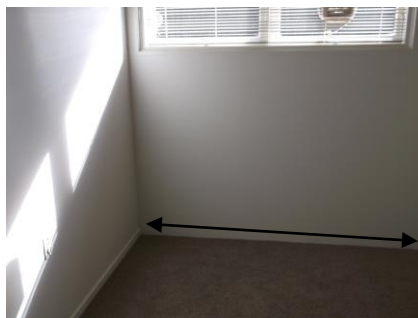
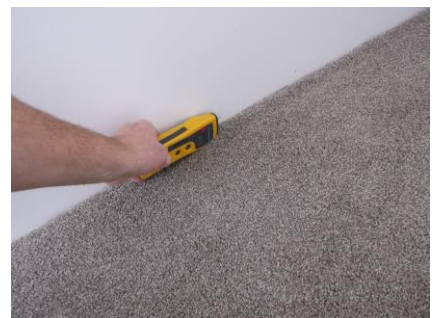
Given location and pattern, damp proofing failures are the suspected cause. Engaging the services of a water proofing specialist to further assess prior to completing all remedial work requirements to a satisfactory conclusion.

Right and below right –
 High moisture concentrations detected provide evidence of moisture entry caused by DPM failures to the subterranean wall surface adjacent.

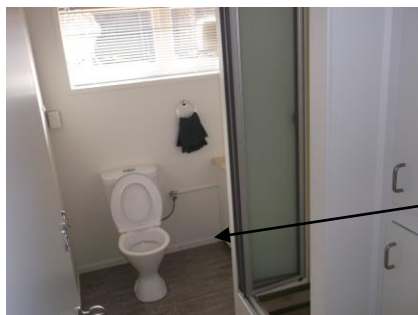
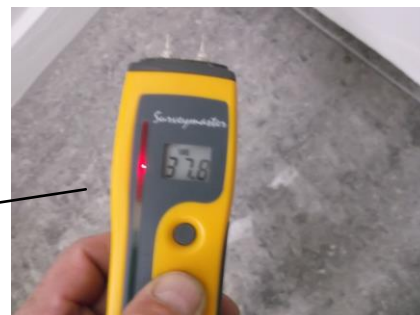
Given location and pattern, damp proofing failures are the suspected cause. Engaging the services of a water proofing specialist to further assess prior to completing all remedial work requirements to a satisfactory conclusion.

Right – High moisture concentrations detected provide evidence of moisture entry caused by DPM failures to the subterranean wall surface adjacent.

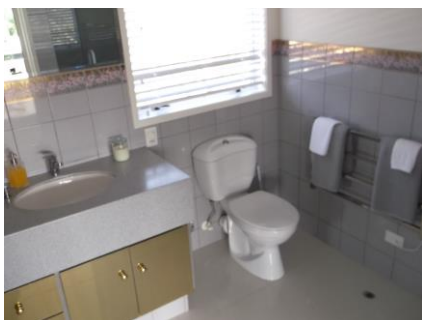
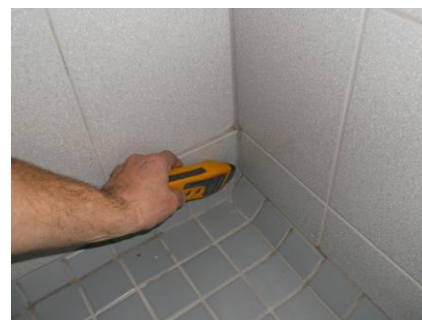
The ensuite bathroom is in generally good / average condition. Although no serious defects were visible, further assessment of the shower cubicle will be required. Remodelling may be required.

Moisture concentrations above the accepted average are present in the wall substrate beneath the shower cubicle tiled finished wall surface to low level areas.

Right – Elevated capacitance moisture findings and visible defects suggest on-going concerns associated with water proofing failures (assumed). Further investigation / monitoring will be required.
