'Standard' Residential Property Inspection On

Date of inspection: 29th October 14
Weather conditions: Variable with showers
Previous Weather conditions: Variable with showers
Compass bearing from official front door: South East facing

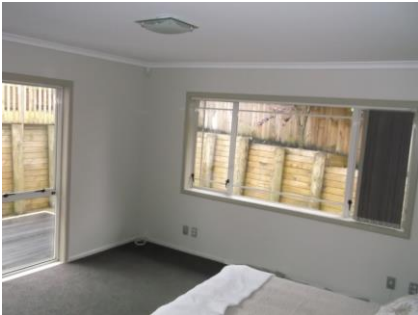
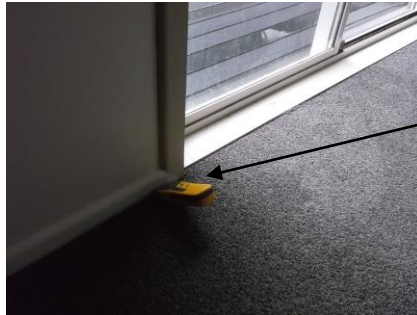
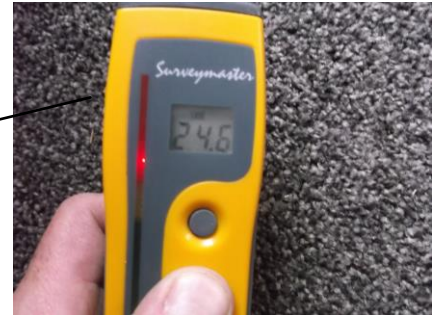
1. In the main bedroom skirting trim local to the exterior door L & R/H sill corners – 24.6% WME and Capacitance mode

Moisture accumulations here indicate collected water in the door sill channel is 'wicking' past unsealed mitred joinery. Attention will be required.

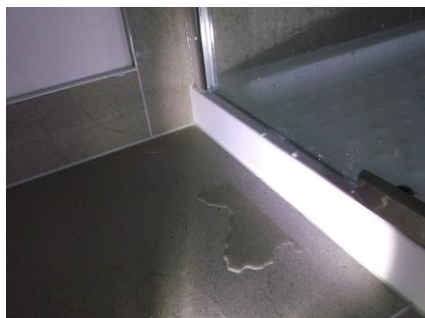
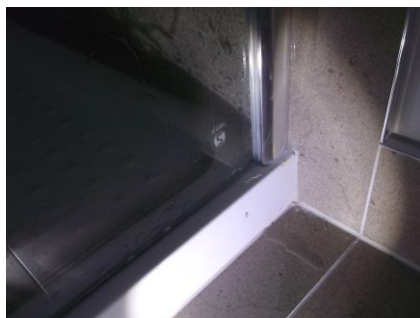
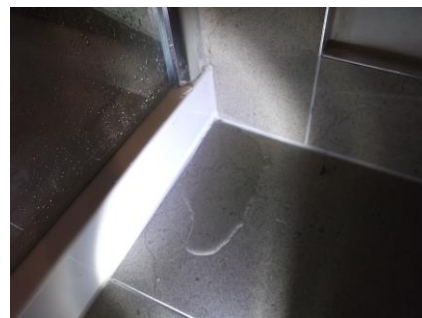
Although recently installed, tests provide evidence of failures and leak events.

- Employing the services of a trade registered specialist to remove and reinstate the shower cubicle frames using appropriate sealant provisions to solve current leak issues sighted under test conditions.

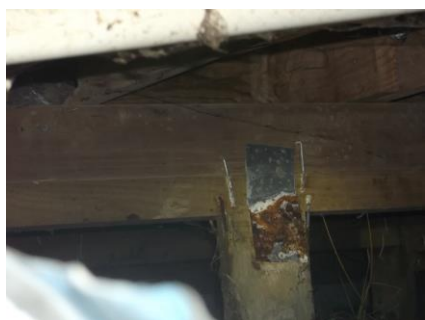
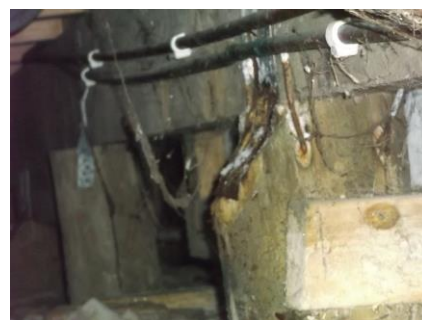
Foundations: The concrete block work interior and exterior foundations are in generally good condition. No movement flaws associated with structural deficiency are visible.
The timber pole interior and exterior foundations are in average order. Although no serious movement failures associated with structural deficiency is noted, significant galvanic and ferrous corrosion issues are visible to some galvanised steel connector plates. Replacement connector plates and fastenings using stainless steel will be required.

- Employing the services of a trade registered professional to replace inferior pile / bearer galvanised connections.

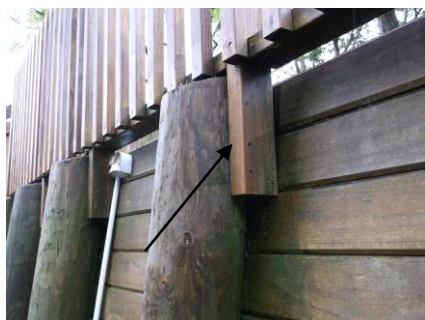
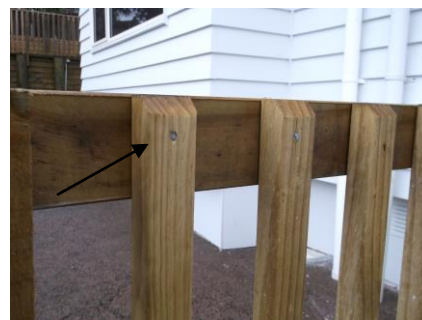
Left – Further securing using stainless steel M12 bolts with 50mm washer plates / suitable coach screws with washer plates. Right – Singular nail fastenings is considered inferior.

- Employing the services of a trade registered professional to upgrade the retaining wall handrail fastenings.

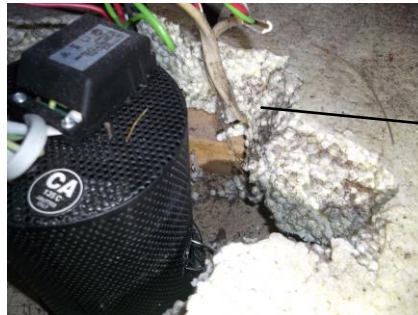
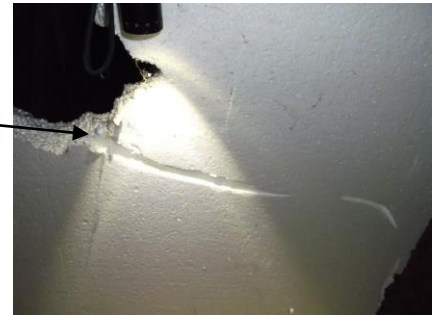
Right – PVC plasticiser migration is noted (where visible).

- Employing the services of a trade registered professional to further insulate all affected contacting PVC wiring against polystyrene insulation.

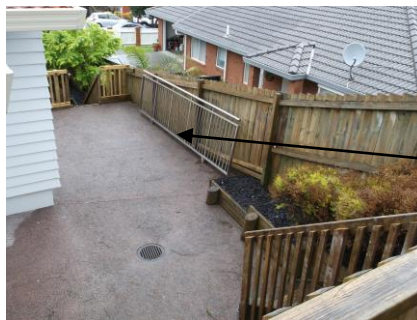
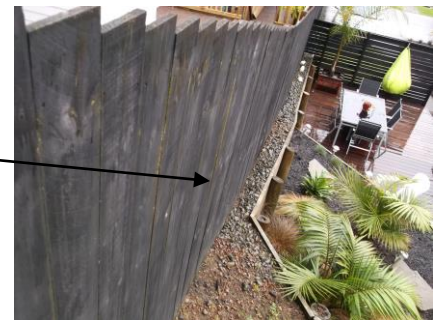
Right – Fence line sighted obscures views of any retaining provision.
 Concerns over structural capabilities are noted.

- Employing the services of a trade registered professional to further assess the retaining provisions associate with the S/W elevation boundary.

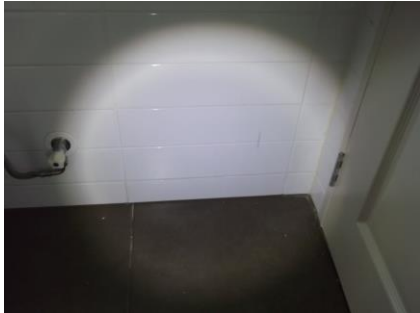
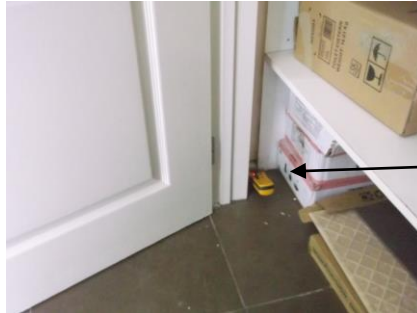
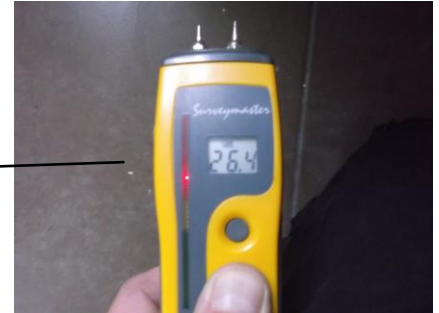
1. In the S/W bathroom wall linings to an extended area – 26.4% WME and Capacitance mode

Plumbing leak events associated with the fire hose spur are suspected to be the cause (assumed).

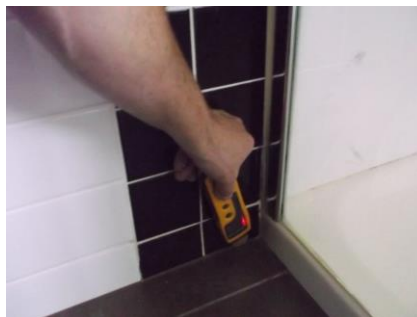
2. In the bathroom wall linings beside the shower cubicle L/H base corner – Capacitance mode

Right – Moisture findings here are as a result of sighted on-going shower cubicle leak events.

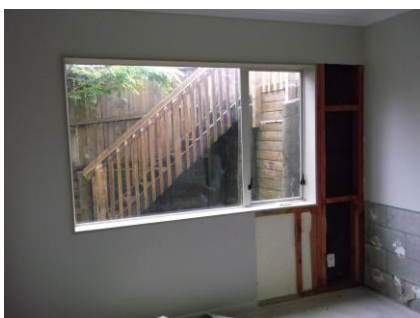
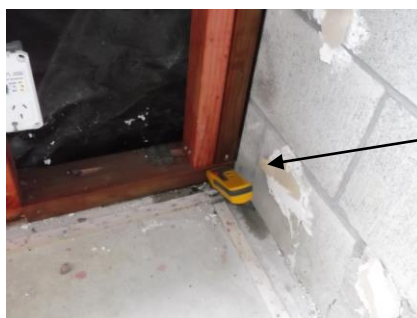
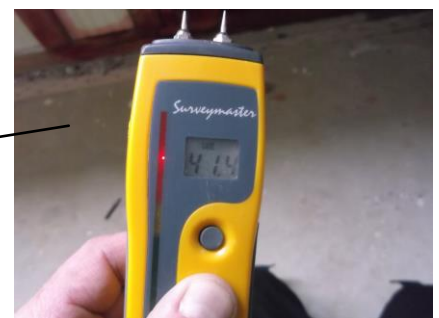
3. In the W corner bedroom W corner exposed timber framing – 41.4% WME and Capacitance mode

Exterior detailing compromising the vertical DPC is the cause. Attention will be required.

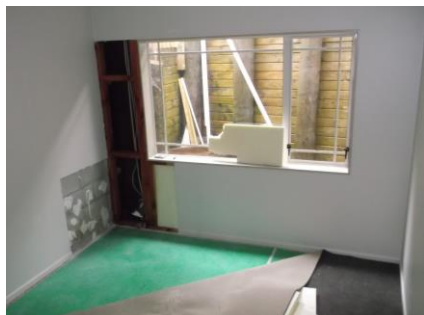
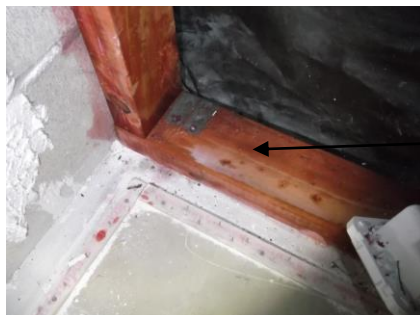
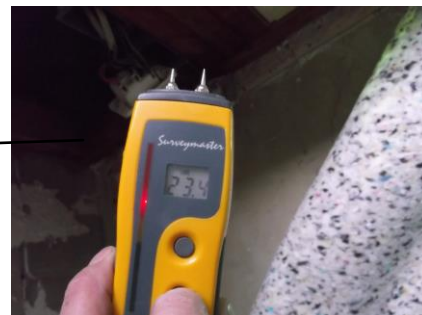
4. In the N corner bedroom N corner exposed timber framing – 23.4% WME and Capacitance mode

Exterior detailing compromising the vertical DPC is the cause.
Attention will be required.

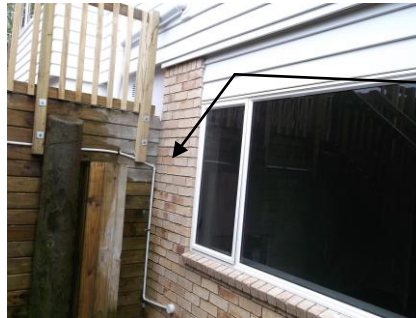
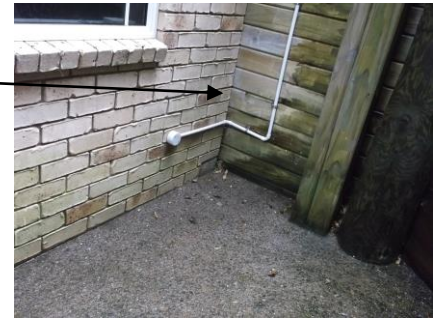
Cladding: The brick veneer is in average condition. Ground clearance and vertical DPC issues are visible. Remodelling to prevent moisture ingress / egress is strongly recommended / required.

Right – Inferior design detailing here will continue to allow an uncontrolled quantity of moisture ingress / egress beyond the brick veneer.

- Employing the services of a trade registered professional to remodel the exterior ground clearance and vertical DPC compromises causing on-going moisture ingress related issues noted in bedrooms 1 & 2.

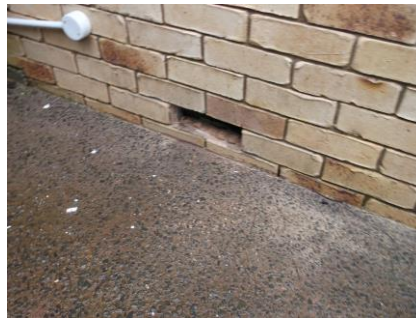
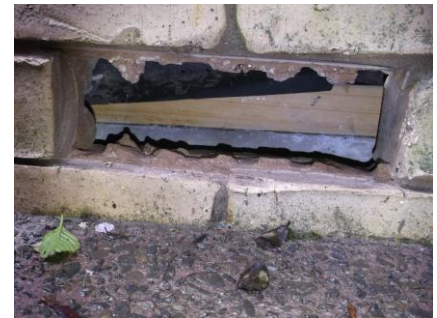
Right – Concrete finish compromises are noted. Although lower areas allow drainage, water is encouraged to collect within the wall cavity. Unknown quantities of debris accumulations and potential blockages have the ability to allow moisture ingress beyond the building line. Attention will be required

- Employing the services of a trade registered professional to perform invasive investigations to assess the level of moisture penetration damage and ascertain the cause/s prior to completing all remedial work to a satisfactory conclusion.

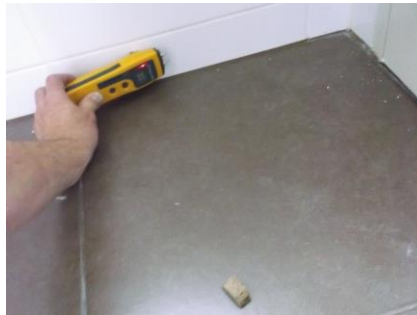
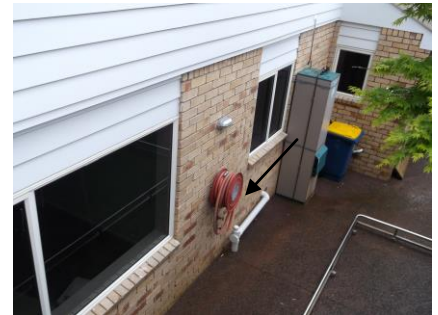
Right – Suspected leak events associated with the fire hose plumbing.

- Employing the services of a trade registered professional to further assess the assumed plumbing leak event and ascertain damage (if any) to local timber framing associated with the bathroom S/W elevation.

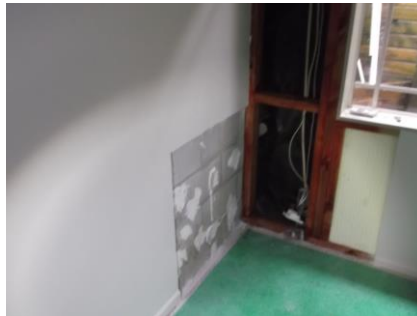
Recommendations: Sealed unit double glazing is recommended
Note: Polystyrene insulation is in contact with PVC / TPS wiring. Plasticiser migration activity is suspected. Further assessment will be required.

- Employing the services of a trade certified electrician to further assess the likelihood of PVC plasticiser migration issues associated with the minor dwelling wiring.
