Weather Tightness and Moisture Test Inspection on Sample

We were requested to perform a weather tightness survey and full non-invasive moisture test inspection on your address:

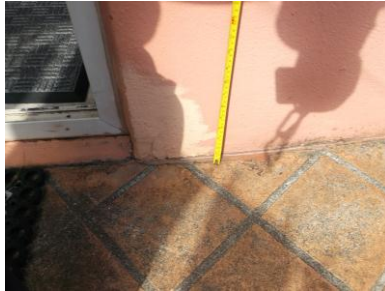
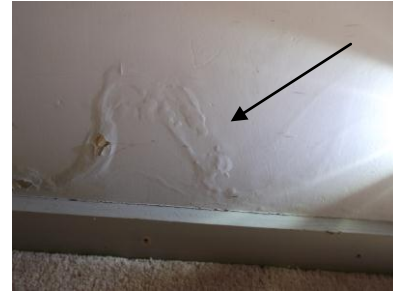
The texture finished solid plaster over concrete block ground floor exterior is in average / poor condition. Ground clearance compromises and penetration defects are visible to many areas. Urgent attention will be required to create effective ground clearance and complete remedial work to the damp proofing failures sighted to extended areas associated with the subterranean aspects.

Right – Ground clearance compromises sighted are allowing capillary moisture entry. Creating appropriate clearance will be required. Channel drainage provisions and reducing the plaster to form an effective clearance breach is required to suppress further ingress concerns.

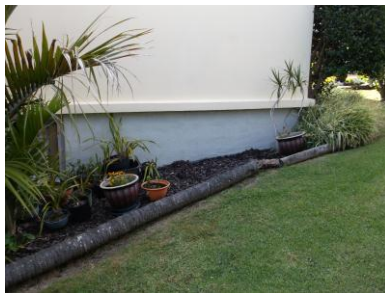
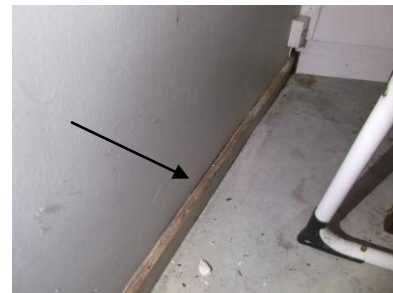
Right – Subterranean DPM failures are expected and inferior / no drainage provisions are suspected to be the causes for excessive moisture entry identified in the garage (where access allows).

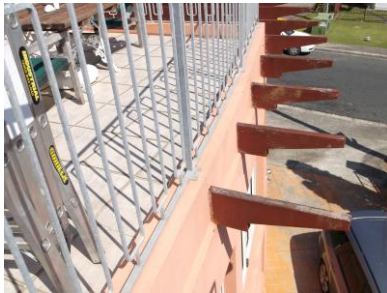
The texture finished solid plaster over backing substrate first and second floor exteriors are in average / poor condition.

Ground clearance compromises are visible to decking intersections and direct fixed penetration defects are visible to many areas including (and not limited to) handrail fixings and timber aesthetic rafter feet projections. Urgent attention will be required to create effective ground clearance and complete associated upgrading remedial work.

Note: Door and window joinery height reductions will be required to accommodate for the required 100mm up stand detail with the current decking design.

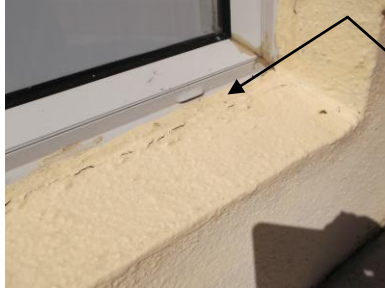
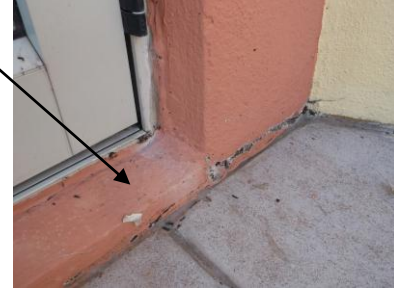
Attention will be required to this detailing where current solid plaster formed plinth details compromise the inferior aluminium joinery unsealed mitres and allow defects to drain / 'wick' moisture within the building line.

Right – Plaster finish above the aluminium window and door sill joinery in incorrect weather tightness best practice. Attention will be required to remodel these details including the installation of a mechanical sill flashing detail.

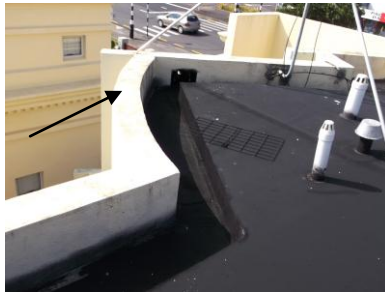
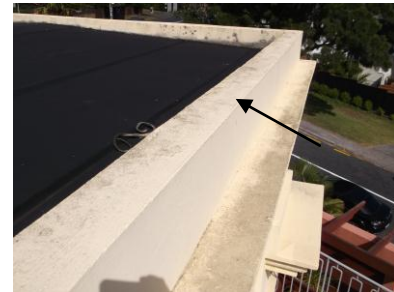
The cladding parapet walls appear finished level with plaster and paint finish. Installing appropriate mechanical saddle flashing details with a +3 degree inward fall will be required.

Right – Parapet wall horizontal surfaces must be considered roofing components and should be suitably detailed. The use of angled mechanical flashing details will be required.

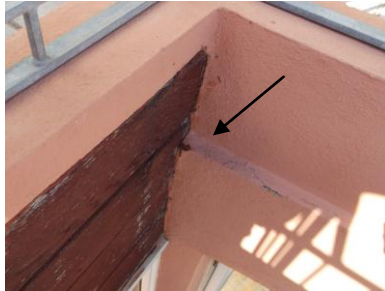
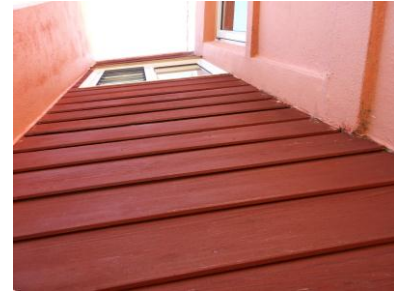
Right – Current flashing detailing / weather tightness provisions are not visible. Upgrading these intersections to suit a visible mechanical detail is required.

Remodel the Cedar timber weatherboard / solid plaster intersection details will be required.

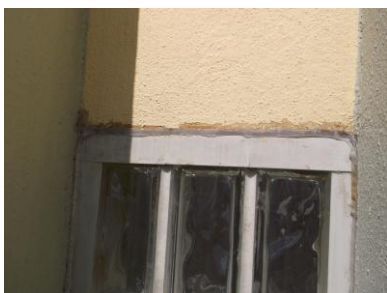
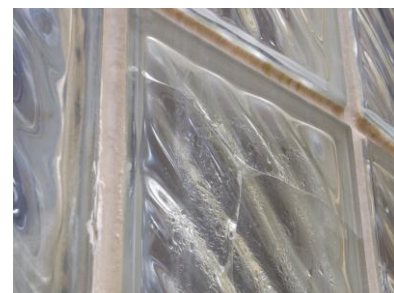
The glass brick window detailing is poor with no head or sill flashing details.

Glass brick window designs of this era are recognised as problematic and prone to leak event failures.

Liberal sealant applications sighted suggest leak events are on-going or prone to re-establishing.

Left – Current glass brick window weather tight provisions are inferior and heavily reliant of retrospective silicone sealant applications. Right – Grouting to some areas has been further sealed using a silicone based product in an attempt to repel moisture ingress.

Remodelling the glass brick windows using appropriate flashing details or replacing with suitable fixed frame alternatives will be required.

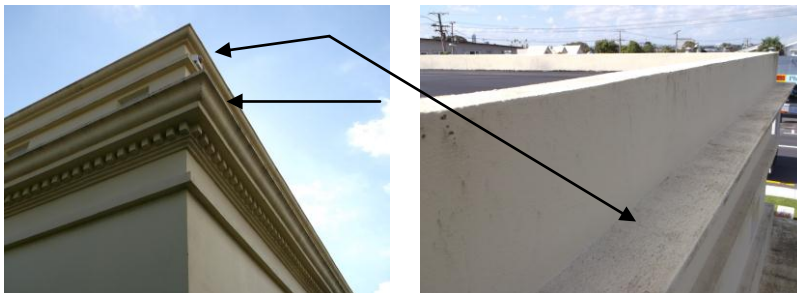
Although the decorative elaborate polystyrene moulded detailing appears in generally good order, these details are heavily reliant on paint and sealant application to prevent water egress into the void behind and into the susceptible assumed unprepared plaster beneath.

Although this constitutes a considerable aesthetic appeal to the dwelling, these details should be considered risk associated and prone to potential failure.

Right – Attention is strongly recommended / required to remodel these details including the installation of a mechanical sill flashing detail to present a permanent satisfactory weather tight solution.

Installing suitable mechanical flashing details with a suitable up stand against the building line and formed 'drip edge' projection is strongly recommended.

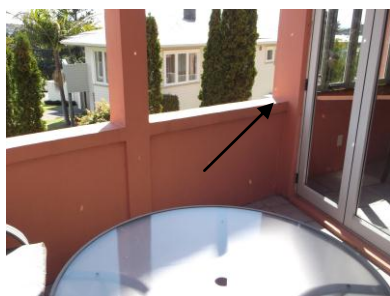
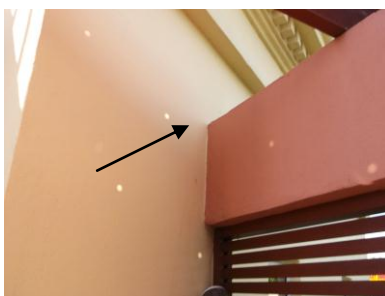
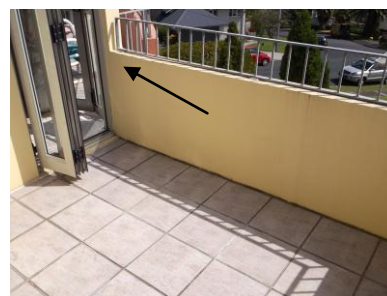
The decking solid formed balustrade and wing walls have been finished level with plaster and paint finish.

Horizontal surfaces must be considered roofing components and should be suitably detailed.

Installing appropriate mechanical saddle flashing details with a +3 degree inward fall will be required.

Remodelling the wall / balustrade junction to suit E2 (weather tightness) / AS/1 (durability) acceptable weather tight solutions will be required.

The use of angled mechanical flashing details will be required installed with negative detailed apron up-stands against the building line.

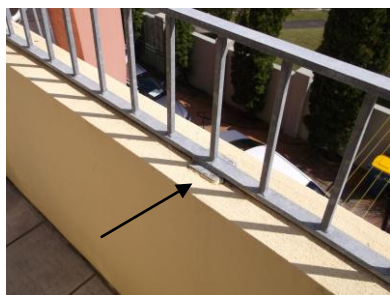
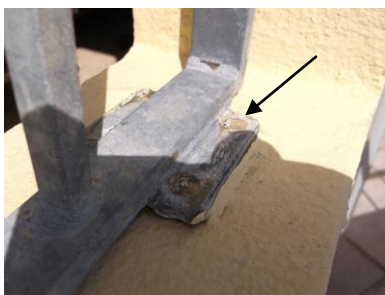
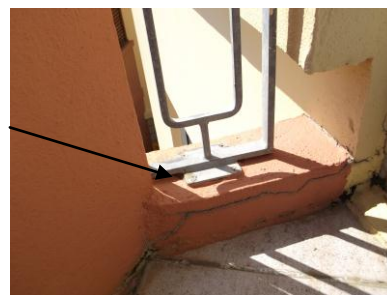
The steel handrail base fixing points are considered high risk and prone to leak event failures.

Liberal sealant applications sighted suggest leak events are on-going or prone to re-establishing.

Sealant application suggests awareness of likely on-going leak events.

Remodelling the handrail fixing points to suit a vertical mounting bracket will be required.

Remodelling the horizontally attached handrail brackets to suit and external vertical bracket will be required.

Invasive investigations will be required to assess the level of moisture penetration damage.

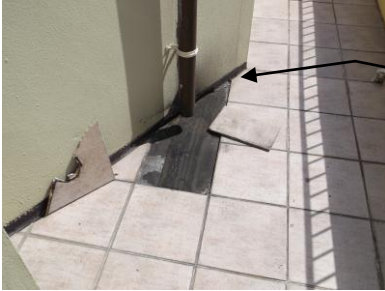
Tiled finished Butynol is recognised as high risk and prone to significant failures.

Remodelling the decking areas to include a 100mm up-stand beneath the door and window joinery to accommodate the replacement membrane requirements to suit a permanent weather tight solution will be required. Upgrading surface water collection overflow provisions to suit a 200 x 75mm opening allowing no more than 20mm of standing water at its lowest point will be required.

The use of a torch-on membrane such as a Nuraply or TPO product is recommended with a sectional and removable open slat timber decking overlay.

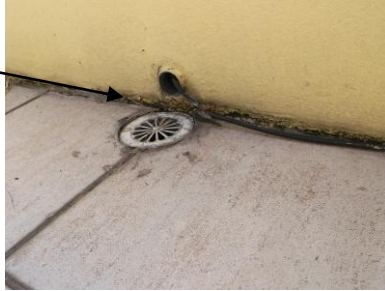
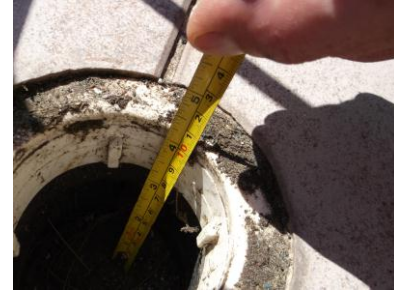
Inferior remodelling sighted to the S/E decking are now discharging the main roofing surface storm water flows onto the internal decking with minimal, already insufficient drainage provisions.

Drain pipe bore is 45mm to each decking area.

Note: Each deck has only 1 drainage point.

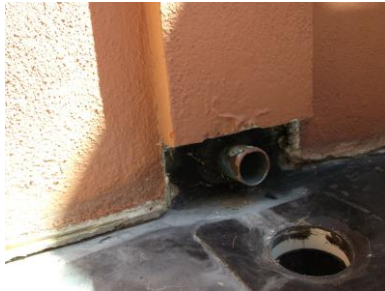
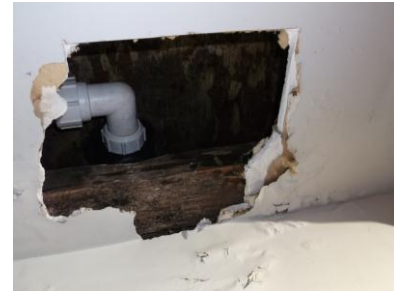
Rot affected timber is visible to the main N elevation decking substrate. Further rot / moisture damage / mould or fungal decay species are likely present.

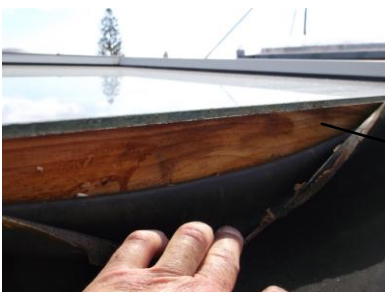
The low gradient Butynol roofing membrane will require attention to the skylight up stands where loose and failing weather tight provisions are noted.

Creating clearance from the solid plaster parapet detailing to include a 100mm tolerance will be required.

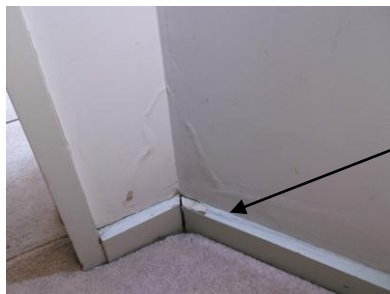
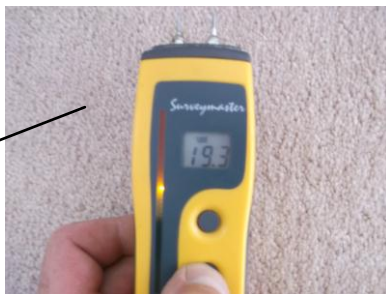
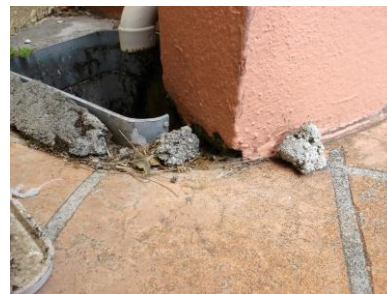
Moisture concentrations above accepted average and visible signatures associated with prolonged moisture ingress are present in the lower ground floor bedroom N corner adjacent to the waste gully. Although ground clearance compromise is suspected as the primary cause, waste gully defects should not be overlooked as a contributory factor.

Signature evidence of on-going moisture ingress is clearly visible.

Elevated readings are noted.

Further invasive investigations will be required prior to remedial work.

Gully details should be further reviewed to ensure no problems.

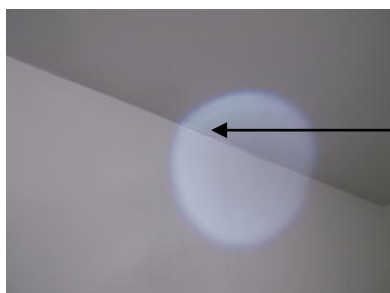
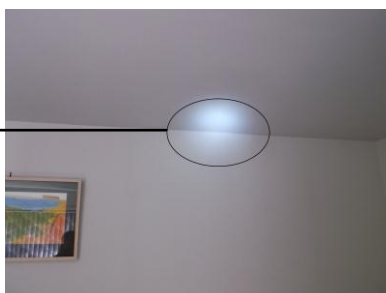
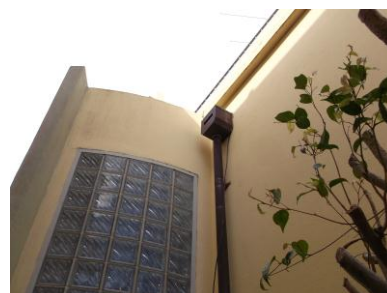
Signatures evidence of moisture penetration is visible to the ceiling adjacent to the ensuite shower room wall abutment.

Moisture testing produced acceptable average results.

'Peaking' acrylic paint adjacent to the ensuite shower wall intersection is signature evidence of likely on-going moisture ingress.

The abutment of the ensuite shower wall and rain head / down pipe are adjacent to the sighted findings.

Further invasive investigations will be required prior to remedial work.

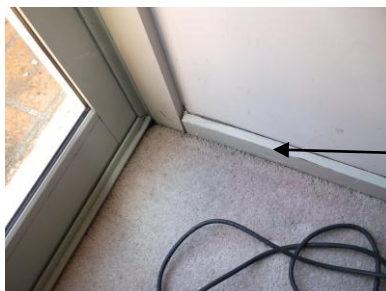
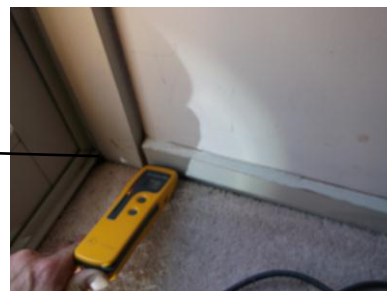
Moisture concentrations above accepted average and visible signatures associated with prolonged moisture ingress are present in the lower ground floor bedroom E corner skirting trim.

Right – 18.9% WME here is likely related to the door joinery failures and / or ground clearance compromises.

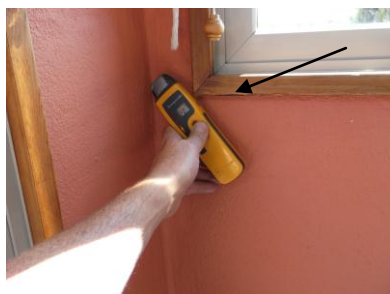
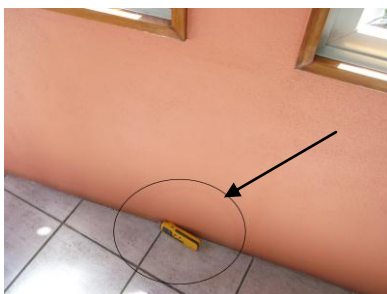
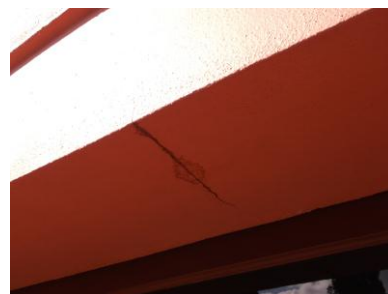
Moisture concentrations above accepted average are present in the dining area local to window joinery sill corners and below in the low level plasterboard / bottom plate.

Window joinery mitre failures are suspected although solid plaster detailing against the joinery is a likely contributory factor.

Evidence to suggest significant moisture ingress is visible to the garage lintel below.

Further invasive investigations will be required prior to remedial work.

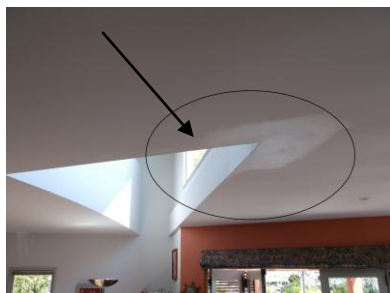
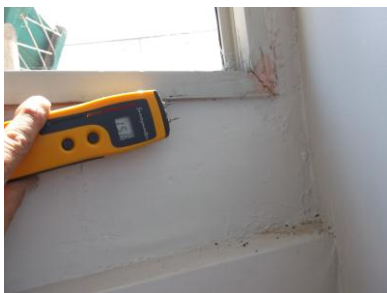
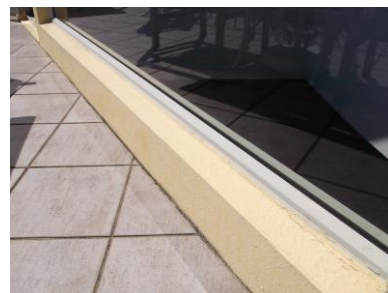
Moisture concentrations above accepted average and associated visible signatures are visible to the ceiling, wall linings and window sill linings / trims local to the main bedroom E/E elevation window sill R/H corner.

Decking membrane up-stand failures, window joinery mitre defects and plaster / window detailing are the likely causes for this on-going leak event issue.

Moisture signatures sighted here provide evidence of on-going moisture ingress.

Moisture readings provide evidence of failures.

Further invasive investigations will be required prior to remedial work.

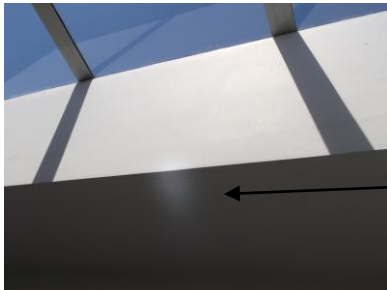
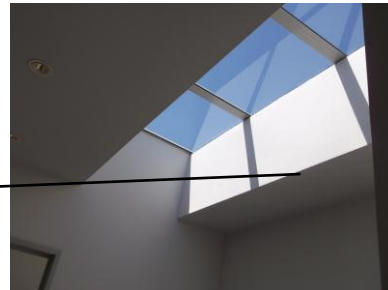
Evidence of moisture entry as a result of failures to the Butynol membrane up stand associated with the mezzanine skylight is visible to the interior plasterboard wall linings local to the skylight opening / ducting.

Right – Moisture signatures here and evidence of failing membrane details adjacent indicate an on-going intermittent leak event.

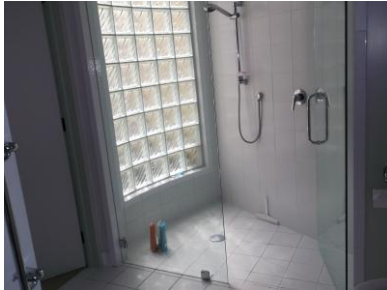
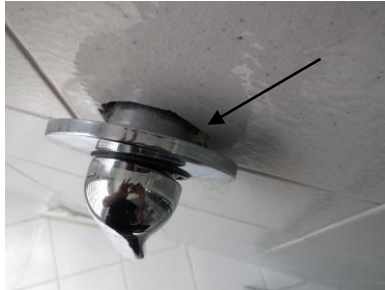
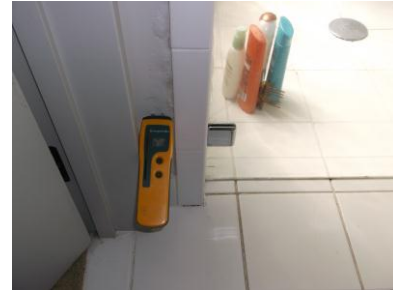
Moisture concentrations above accepted average are present in the and around the ground floor ensuite shower cubicle base and walls.

Leak events sighted from beneath also suggest a waste pipe leak event and rot affected timber flooring structure.

Tiled shower cubicles of this design with tiles directly laid to the suspected particleboard / plywood flooring substrate are recognised as problematic and prone to serious failure.

Plumbing penetrations are noted sealed.

Further invasive investigations will be required prior to remedial work.

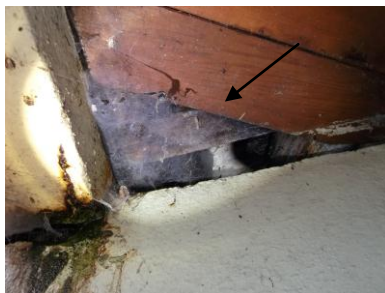
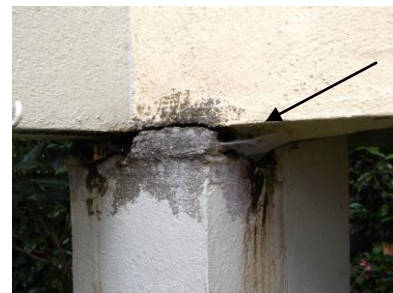
91.8% WME and Capacitance moisture readings taken from the flooring and walls provide significantly elevated moisture levels.

Right – Evidence suggests a long term, on-going leak event from the shower waste fitting (assumed) and possible associated structural movement.

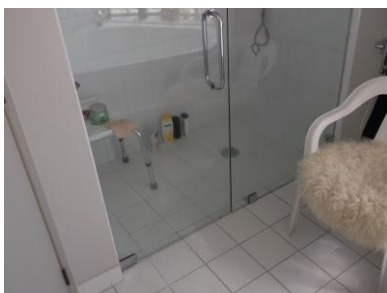
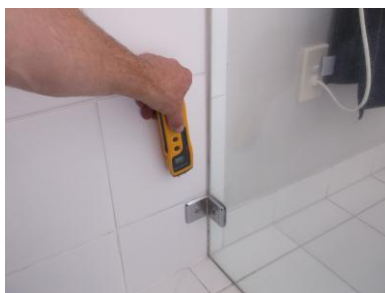
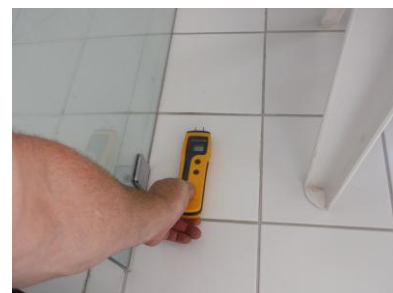
Moisture concentrations above accepted average are present in the and around the first floor main bedroom ensuite shower cubicle base and walls.

Further invasive investigations will be required prior to remedial work.

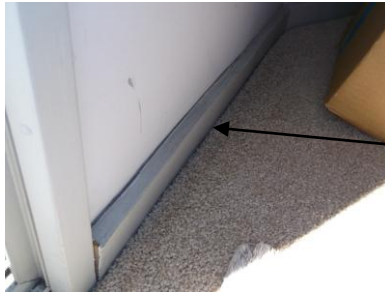
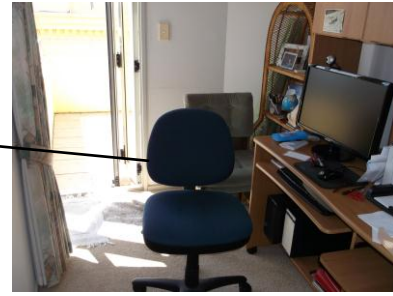
Moisture penetration signatures are visible in the office / study skirting rim adjacent to the decking intersection.

Right – Although moisture testing produced acceptable average results under test conditions, moisture ingress is believed to be on-going.

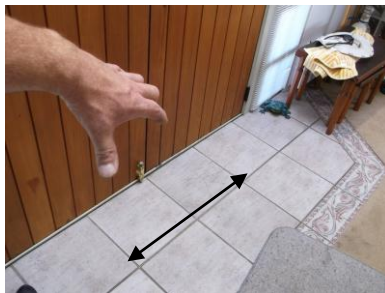
Evidence to suggest moisture penetration and associated swelling signatures are noted to the particleboard local to the front door access.

Right – Although moisture testing produced acceptable average results under test conditions, on-going moisture ingress is suspected.

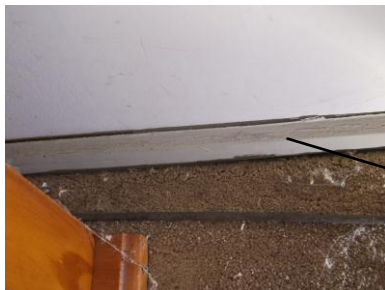
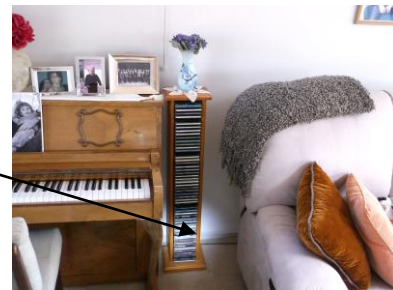
Evidence to suggest moisture penetration and associated signatures are visible to skirting trims in the lounge area beneath some window penetrations.

Right – Although moisture testing produced acceptable average results under test conditions, on-going moisture ingress is suspected.
