Weather Tightness and Moisture Test Inspection on Sample

We were requested to perform a weather tightness survey and full non-invasive moisture test inspection on your address:

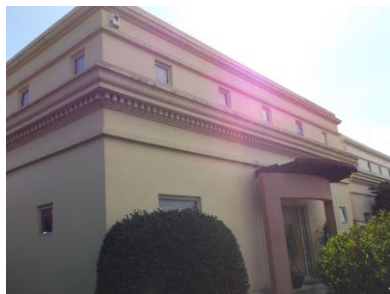
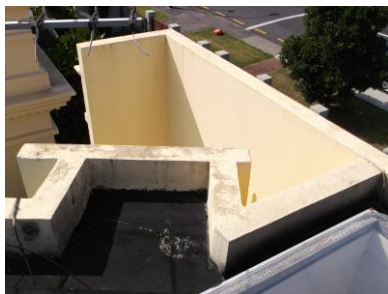
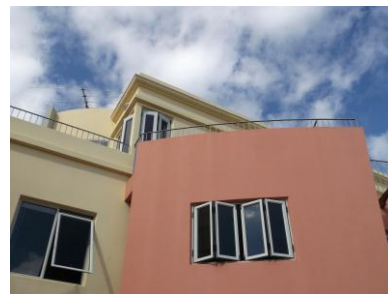
Results:

The texture finished solid plaster over concrete block ground floor exterior is in average / poor condition. Ground clearance compromises and penetration defects are visible to many areas. Urgent attention will be required to create effective ground clearance and complete remedial work to the damp proofing failures sighted to extended areas associated with the subterranean aspects.

Right – Ground clearance compromises sighted are allowing capillary moisture entry. Creating appropriate clearance will be required. Channel drainage provisions and reducing the plaster to form an effective clearance breach is required to suppress further ingress concerns.

Right – Subterranean DPM failures are expected and inferior / no drainage provisions are suspected to be the causes for excessive moisture entry identified in the garage (where access allows).
